Bridge Maintenance & Preservation Strategies for Local Agencies

Alyson Bedard, PE

October 16, 2024

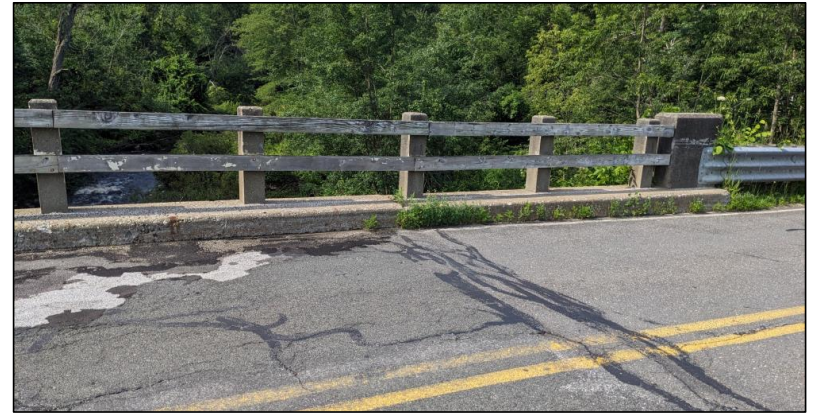
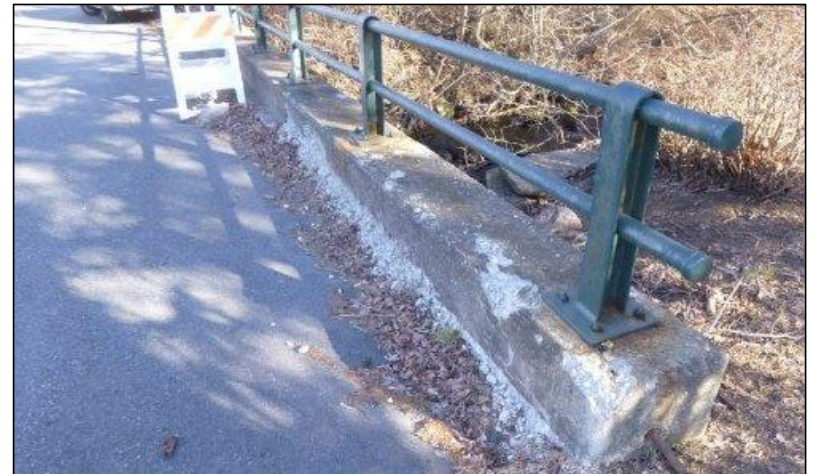
Bridge Sweeping and Debris Removal

- Protects concrete curbs on bridge which are most vulnerable to deterioration
- Keeps road salt off the bridge which prevents chloride penetration
- Extends pavement life
- Prevents puddles, vegetation, moss, and algae from forming on the deck

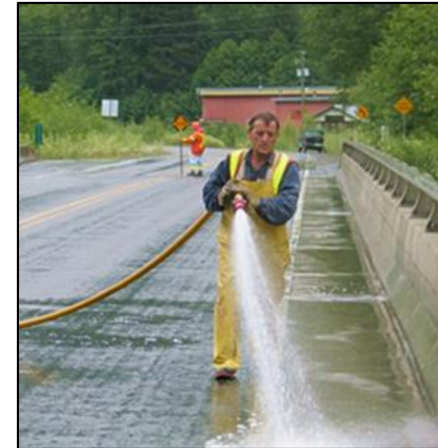
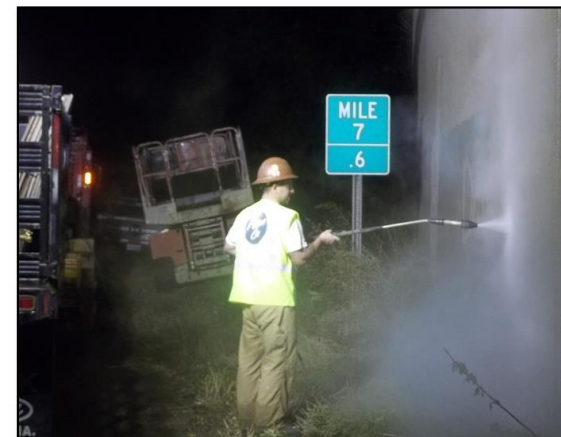
Bridge Washing & Flushing

- Flushing and washing reduces the potential of chloride intrusion in the deck
- Essential for proper joint and bearing movement
- Extends the life of steel coating systems
- Annual washing can extend bridge life

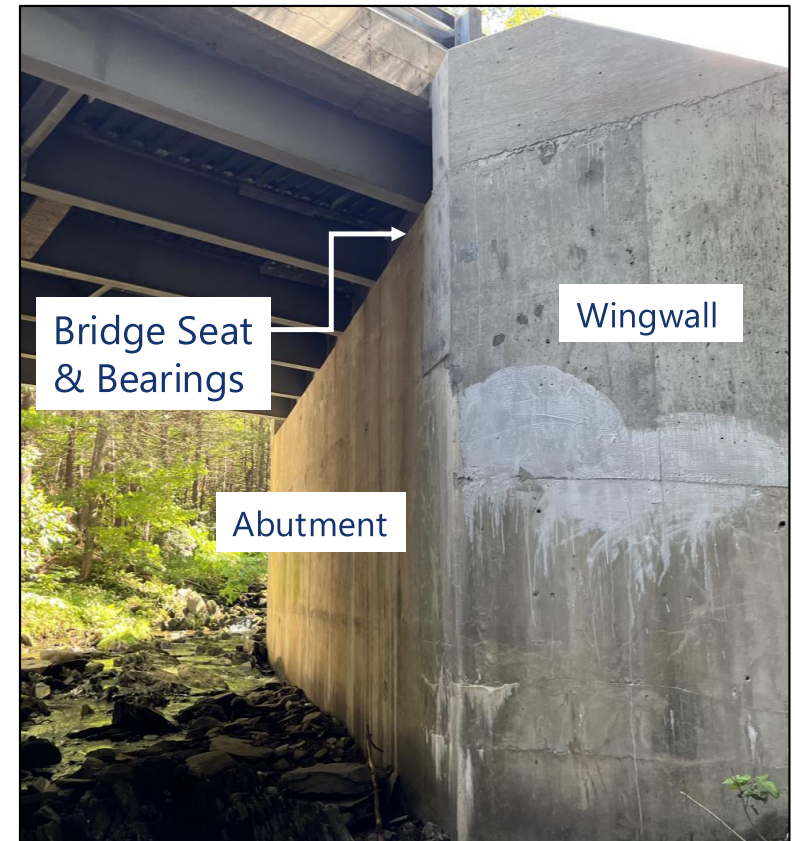
Bridge Washing & Flushing

- Bring a flusher truck, fire truck, or connect to a hydrant to hose down bridge elements
- Sweep & collect any large debris for disposal
- Flush the deck, barriers, faces of abutments & wingwalls, bridge seats & bearings
- Hose down beam ends, trusses, & end diaphragms
- Rinse steel open grate decks

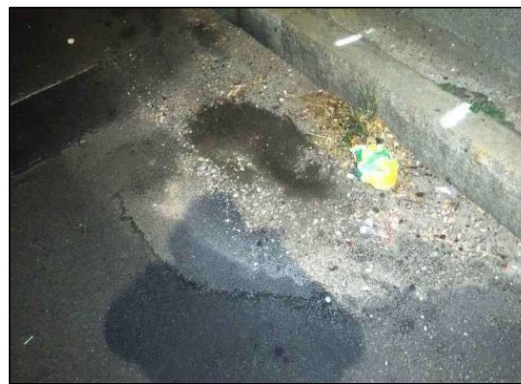
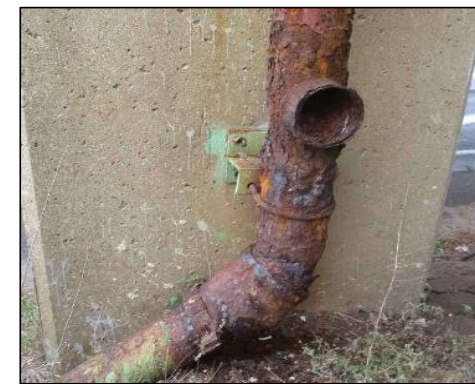
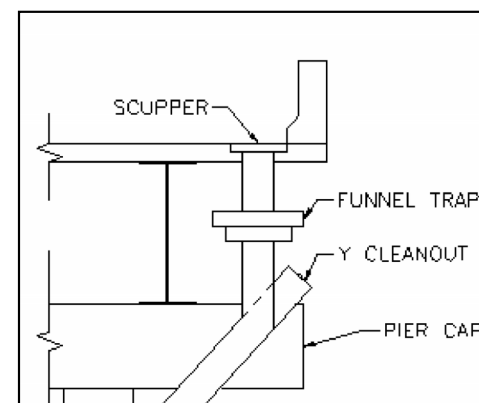
Cleaning Drainage Systems

- Extends life of the deck and pavement
- Prevents chloride penetration into concrete
- Keeps surfaces free of road salt
- Protects exterior beams from deterioration
- Keeps puddles off the bridge
- Prevents drainpipes from overflowing onto steel girders

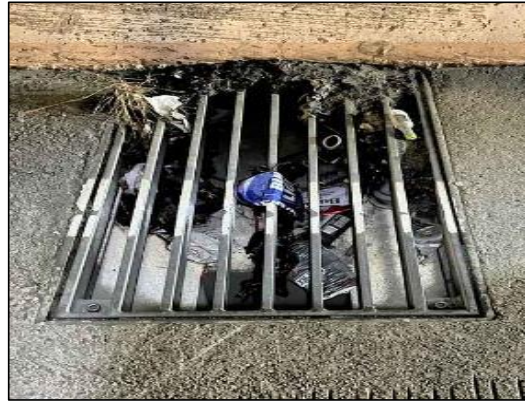
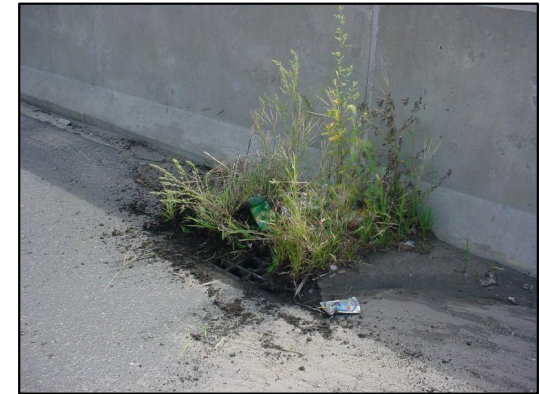
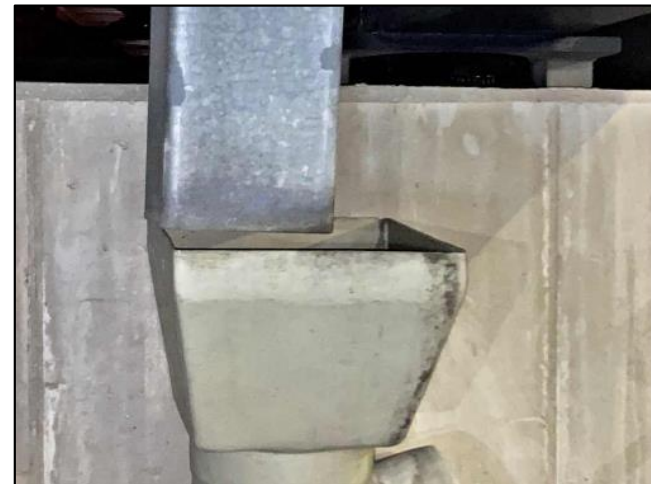
Cleaning Drainage Systems

- Keep catch basins clear
- Extra attention to the bridges at roadway low points
- Ensure swales or catch basins adjacent to bridges are functioning
- Ensure no breaks/misalignments in drainpipes
- Remove and appropriately dispose of debris in catch basins and other parts of the drainage system

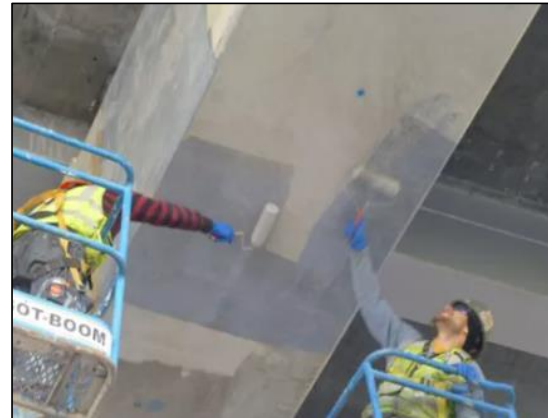
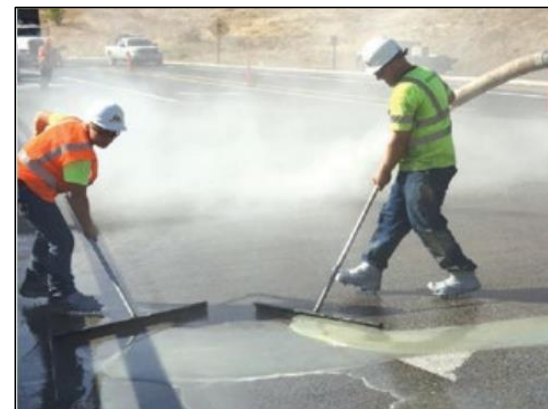
Sealing Exposed Concrete Surfaces

- Select a sealer that is applicable for the intended application since depending on product application may be limited to one or more of the following; horizontal, vertical and overhead surfaces
- Certain products are good for specific applications and other materials (silanes, elastomeric, acrylic, etc.)
- Most have spray, roll on, or brush applications
- Apply every 5 to 10 years, see manufacturer's recommendations

- Achieves a depth of penetration into the concrete that seals and protects without impacting slip/skid resistance
- Protects concrete including reinforcing against deicing chemicals
- Can be used to protect concrete, brick, masonry, cementitious mortar, and natural stones

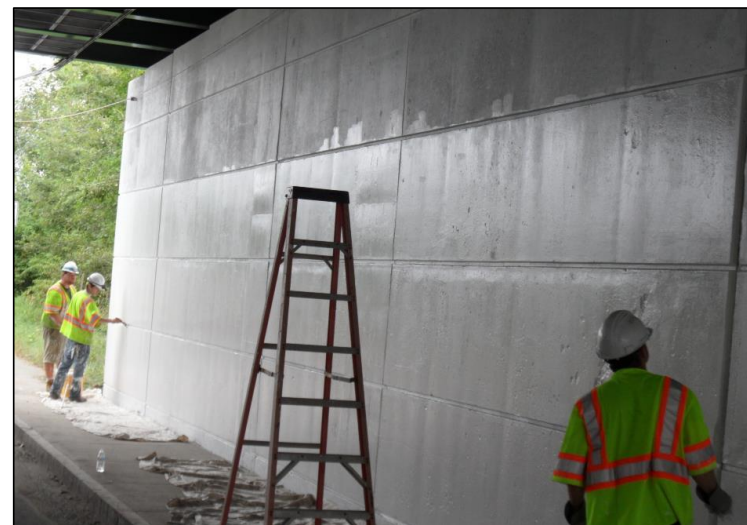
Sealing Concrete Cracks

- Seals cracks in the bridge deck concrete or substructure to prevent the intrusion of moisture, de-icing chemicals and other damaging environmental affects
- Most effective when placed early, after initial shrinkage cracking and prior to exposure to de-icing chemicals

- Variety of Products and Categories available based on crack sizes
- Great for bare concrete deck bridges (no HMA), concrete railings, and substructures
- Not for paved bridge decks - better to apply a full waterproofing membrane
- Extend the life 25+ years

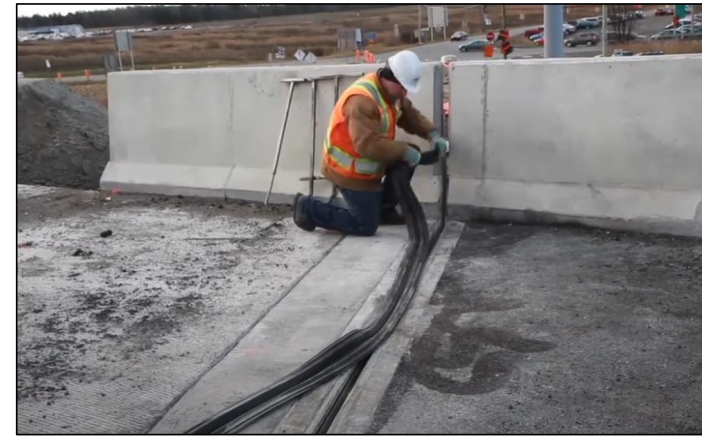
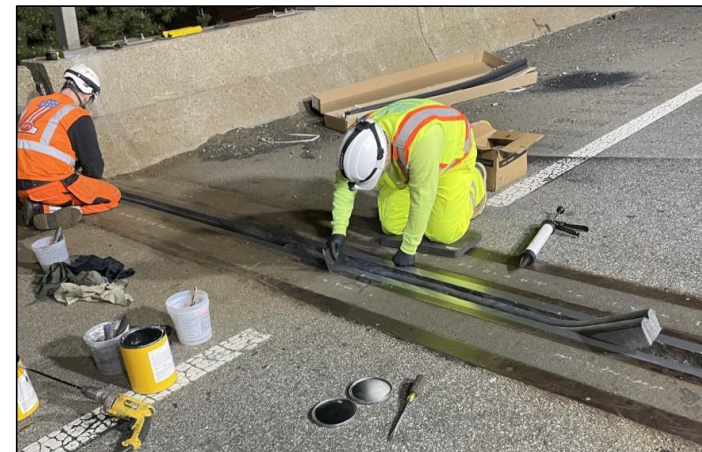
Replacing Joint Seals

- Extends the lifespan of the weakest aspect of the bridge
- Maintaining the joint seals prevents water from getting into your bridge
- Leaky joints lead to rusty steel beam ends - Protect your beams!
- Joint maintenance is the key to bridge longevity!

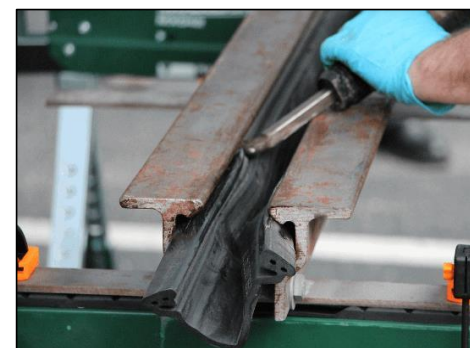
Retrofit Armored Joint with Pre-compressed

- Two seal replacement strategies.
- Replace seal in kind
- Replace with a pre-compressed or other seal type that adheres to sides of joint

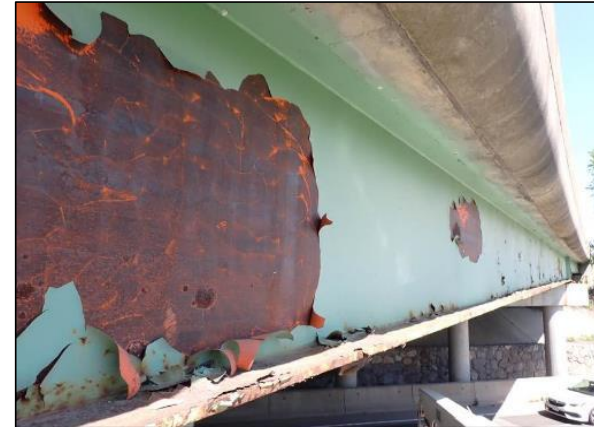
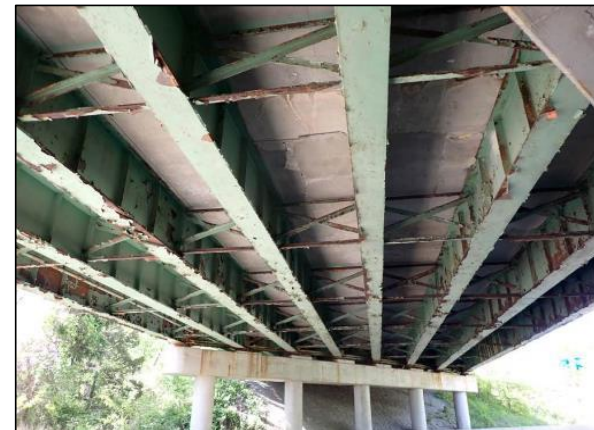
Clean and Paint Steel

- Containment installed and paint removed by power tools or blasting
- Prime coat applied by spray, roller, or brush
- Cured between coats (prime, mid, and finish)
- Worker safety and environmental regulations need to be followed
- Maintenance personnel may perform spot paint repairs if properly trained

- Maintaining the coating system on steel beams is the key to avoiding corrosion
- Cleaning off failed paint and applying a three-coat paint system can provide 25 to 30 years of protection
- Spot painting extends service life of existing coating system
- Cleaning steel also gives the opportunity to clearly see and measure steel deterioration

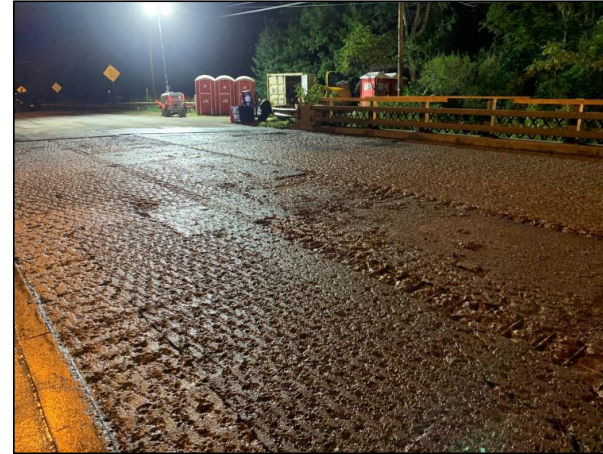
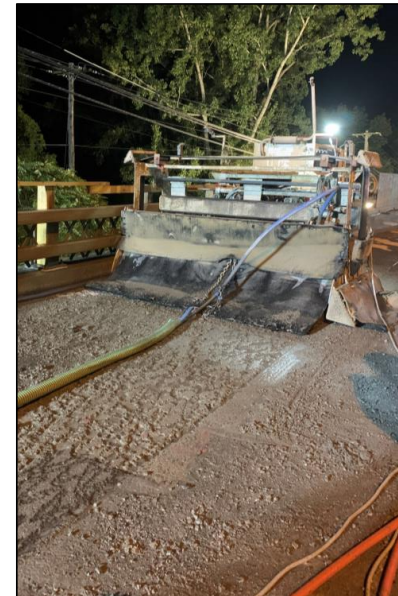
Wearing Surface Replacement

- Protect the deck which is like the roof of your house
- Smooth the riding surface for users
- Most cost effective when installed prior to concrete spalling caused by corrosion of steel reinforcing

- Asphalt Wearing Surface
 - Determine asphalt thickness
 - Mill & Overlay (top surface only)
 - Full Strip with waterproofing membrane or mix
- Exposed concrete decks hydrodemo and overlay

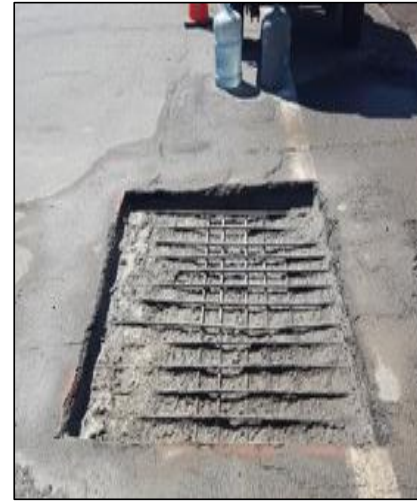
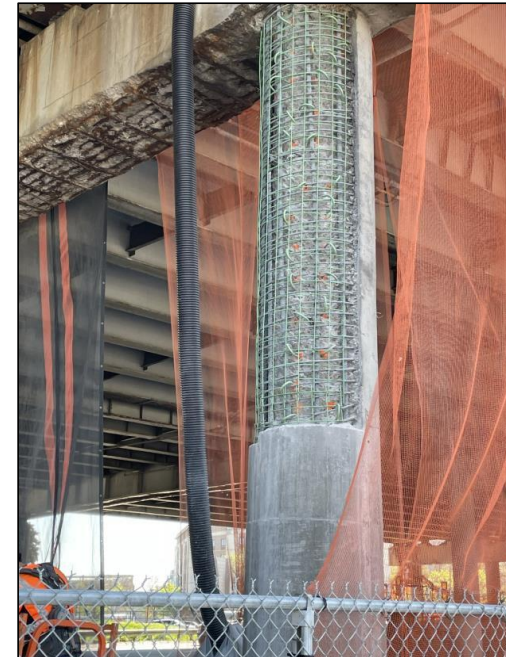
Concrete Patching

- Remove pavement (if present)
 - Mark out extents of repair and sawcut clean edges then use chipping hammer to remove loose concrete
 - Chip out concrete, and expose the rebar (if any) to at least 1" below rebar
 - Thoroughly clean concrete surface, clean rebar, and determine if new bars needed
 - Pour concrete to fill excavated concrete area
 - For Deck Patches
 - Wait until the concrete sets enough and reopen to traffic with a temporary asphalt on top. Typically 2-3 hours with a rapid set.
 - Remove temporary asphalt and place waterproofing and final asphalt at least 14 days after patch has cured.
- ⚠️ If you can close or partially close the road a regular mix can be used to provide longer life to the patches.

- Aids in the protection of rebar from corrosion
- Chipping out deteriorated concrete will expose deteriorated rebar
- Concrete patch materials are less permeable to further protect rebar
- Extend life of your concrete bridge elements

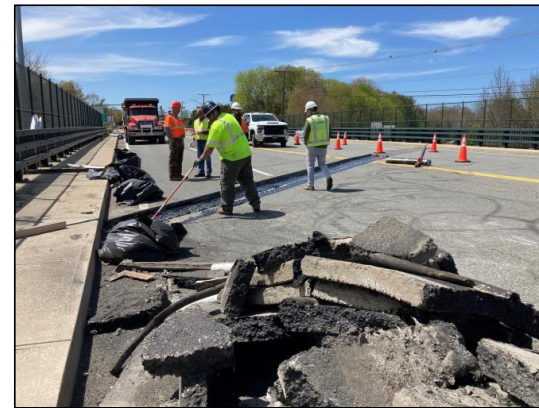
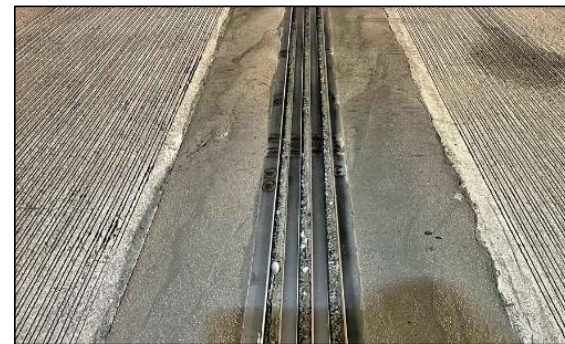
Joint Repair & Replacement

- Vary per joint type but two common examples are strip seal and asphaltic plug
- Strip Seal Joint
 - Retrofit with Pre-compressed joint Replace concrete headers
 - Weld in portion of armoring
- Asphaltic Plug Joint
 - Replace asphaltic binder
 - Replace pre-compressed seal below the binder then do new binder

- Proper joints allow the bridge to move transversely and longitudinally as intended
- Protect the superstructure and substructure elements below the bridge deck from water runoff, adverse chemicals, and debris buildup
- Joint replacement is the best investment you can make in your bridge

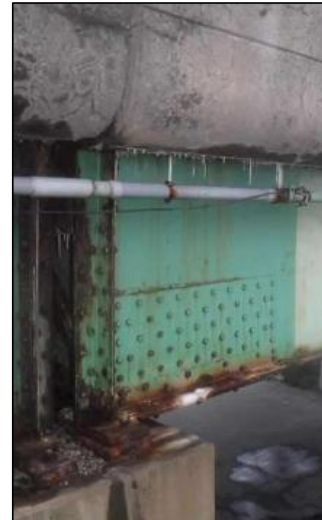
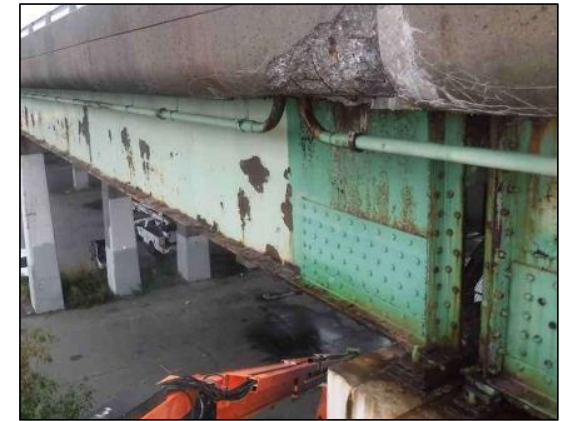
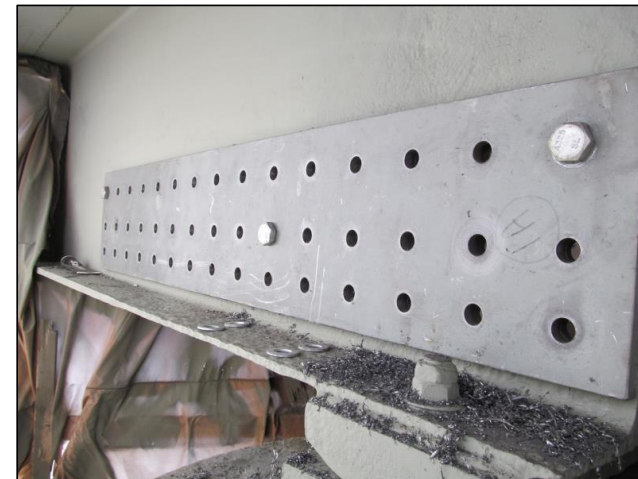
Beam Repairs – Steel Beams

- Clean area of steel
- Ensure area is clean of laitance and oils
- Install repair plates, plates sized to be bigger than deteriorated area
- Paint the repair in-place, existing steel and new plates

- Extend the life of steel beams
- Beam end deterioration is the most common issue resulting in a bridge reduced load capacity (i.e. posting and closure)
- Improve capacity of the beams to the original design or better

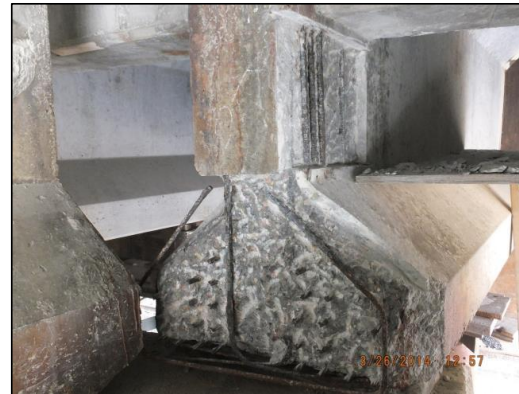
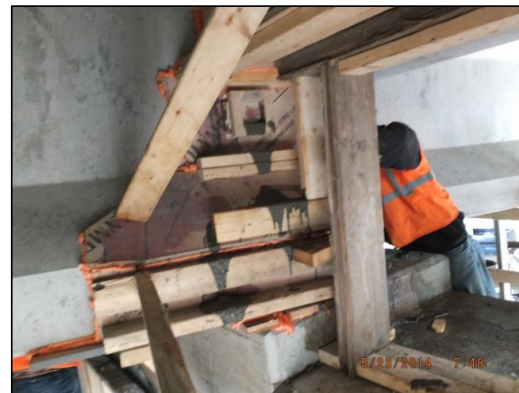
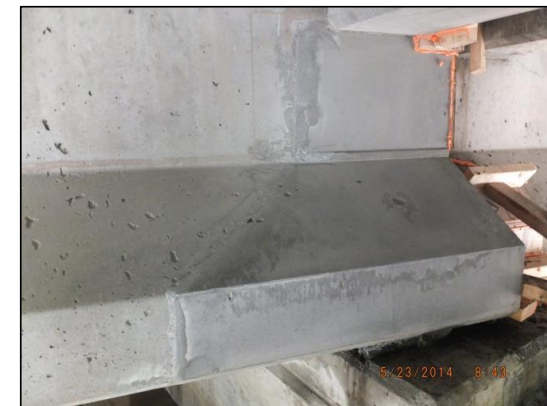
Beam Repairs – Concrete Beams

- Mark out extents of repair and sawcut neat lines
- Chip out concrete, ensuring space behind the rebar
- Check if rebar is deteriorated and determine if new bars needed
- Clean and prep for grout
- Form to original faces of the beam and cast grout

- Extend the life of concrete beams
- Prestressing strand and reinforced steel deterioration effect bridge capacity
- Improve capacity of the beams to the original design or better

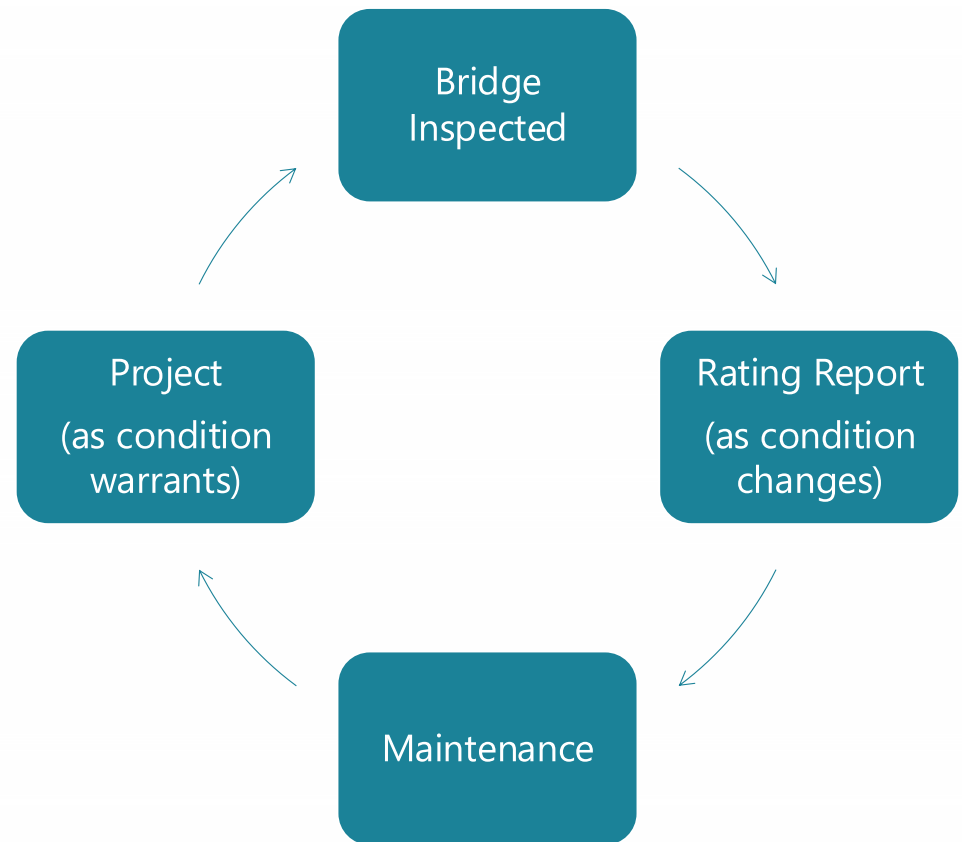
In-Service Bridge Life

During the life of a bridge, it is routinely inspected which can trigger re-rating (evaluation of structural capacity) and maintenance / preservation activities.
